398  
COPY NO.  
RM No. E8C18

# RESEARCH MEMORANDUM

PRELIMINARY RESULTS OF NATURAL ICING  
OF AN AXIAL-FLOW TURBOJET ENGINE

By Loren W. Acker

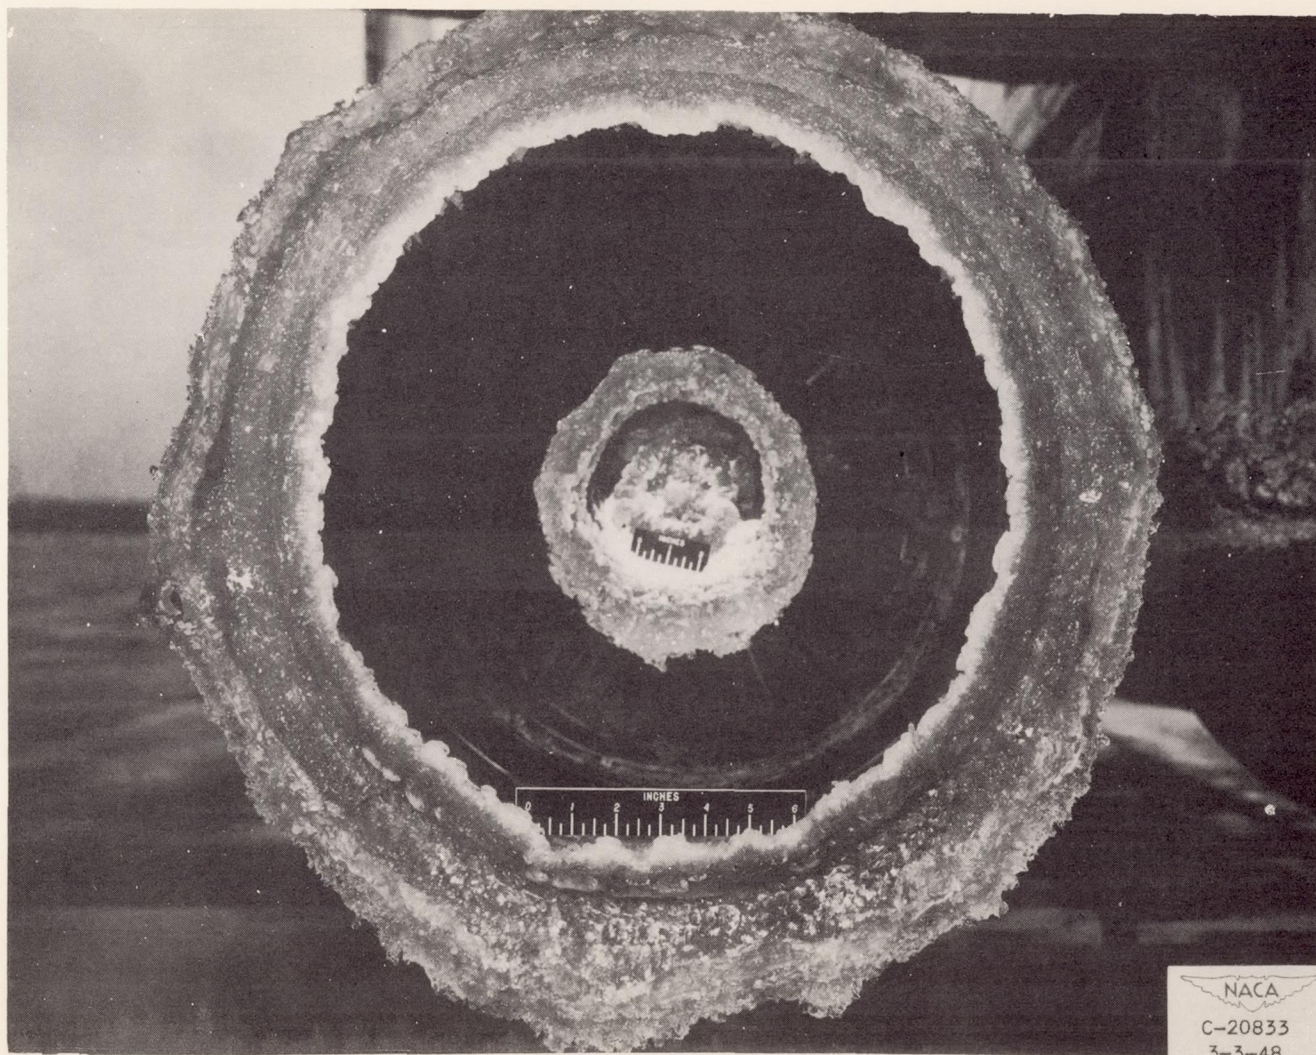
Figure 3. - Ice formation on axial-flow turbojet engine.

Photographs taken after the icing flight are shown in figure 3. A front view of the ice formation on the engine inlet and the starter housing is shown in figure 3(a). The degree of ice accumulation on the engine inlet is indicated in figure 3(b). Ice accumulation on the inlet guide vanes is shown in figure 3(c). Visual inspection of the inlet indicated that ice had accumulated on the first-stage stator blades (fig. 3(c)), the second-stage stator blades, and the first-stage rotor blades. The ice formation on the first-stage rotor blades was concentrated at the leading edge and was approximately 1/8 inch thick. The ice formation on the second-stage stator blades was also concentrated at the leading edge and was approximately 1/32 inch thick and rather sporadic.

(a) Front view of ice formation on engine inlet and starter housing.

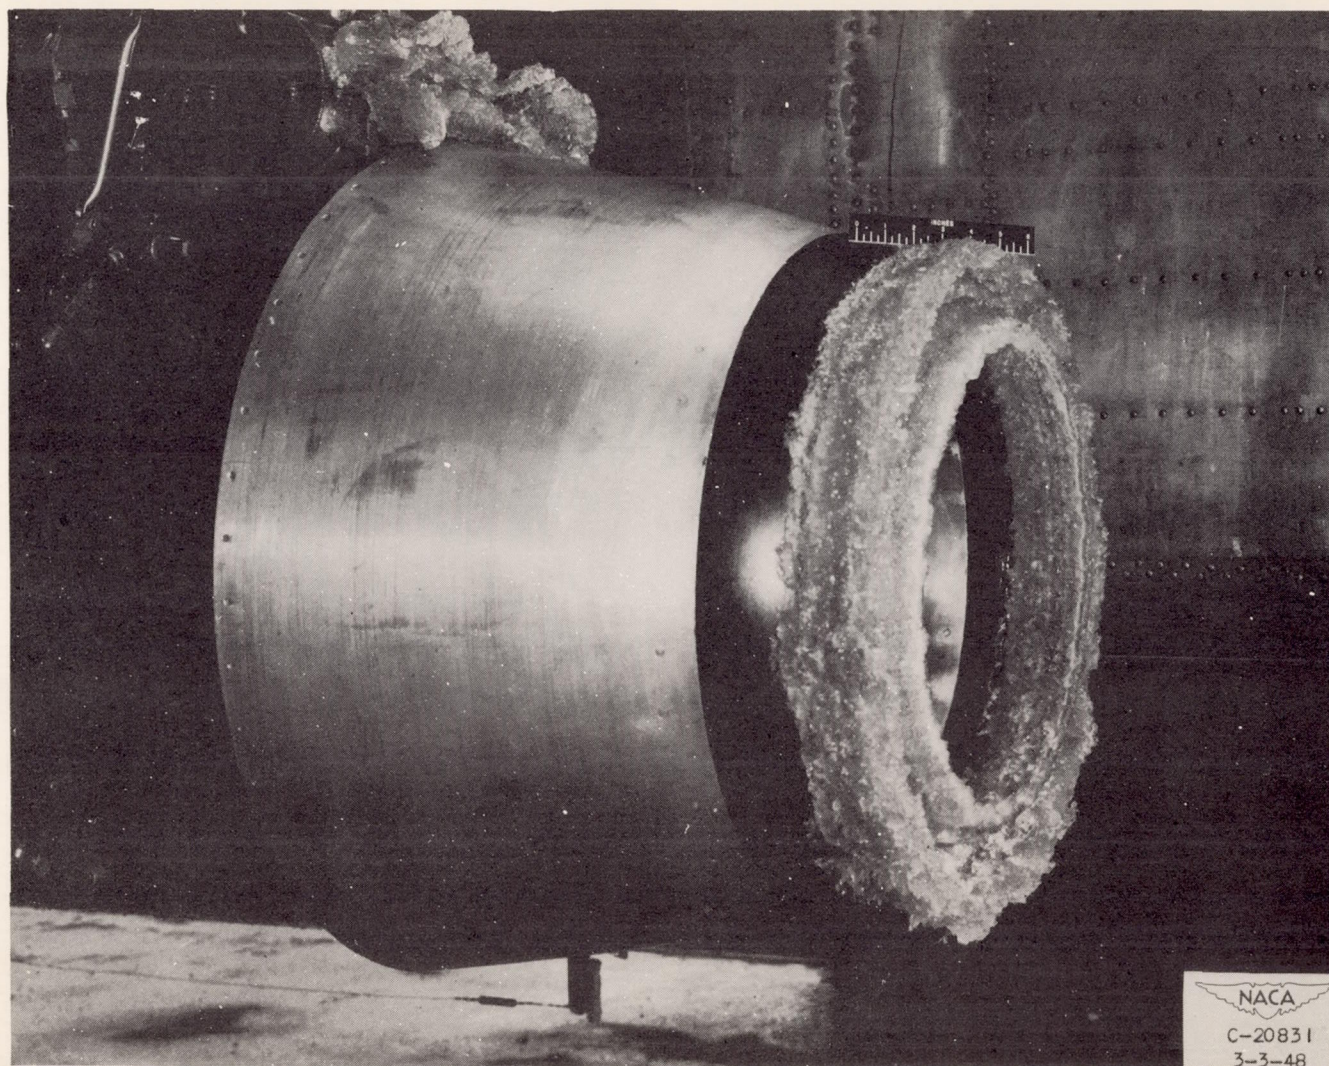
Figure 3. - Continued. Ice formation on axial-flow turbojet engine.

(b) Side view of ice formation on engine inlet.

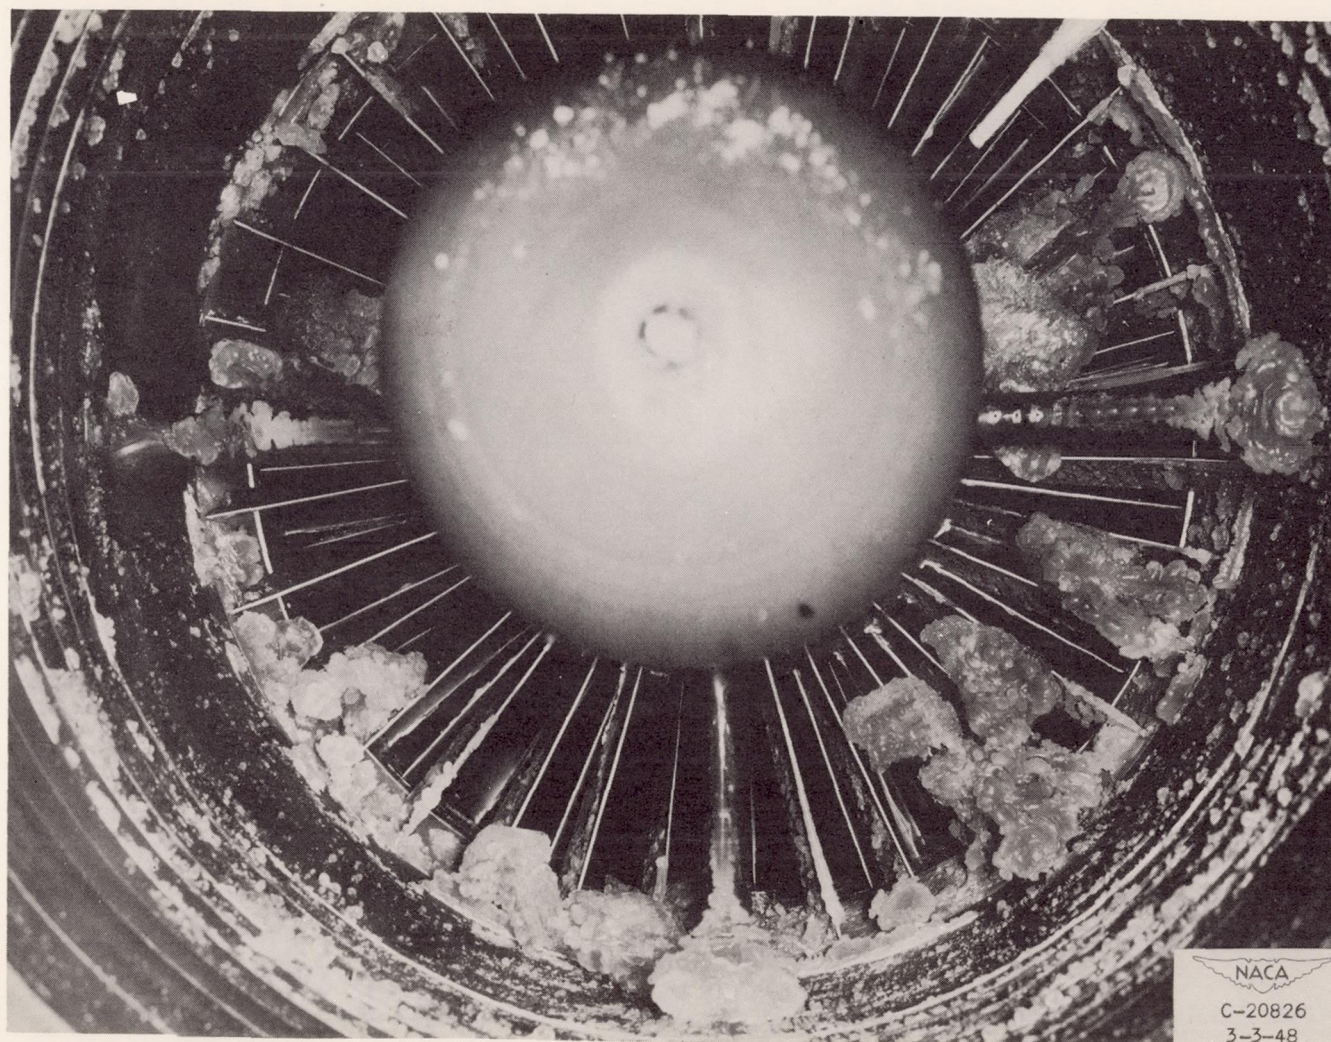
Figure 3. - Concluded. Ice formation on axial-flow turbojet engine.

Inspection of the compressor rotor and stator blades revealed no damage to either from ice throw-off.

(c) Ice on inlet guide vanes (ice on starter housing removed).

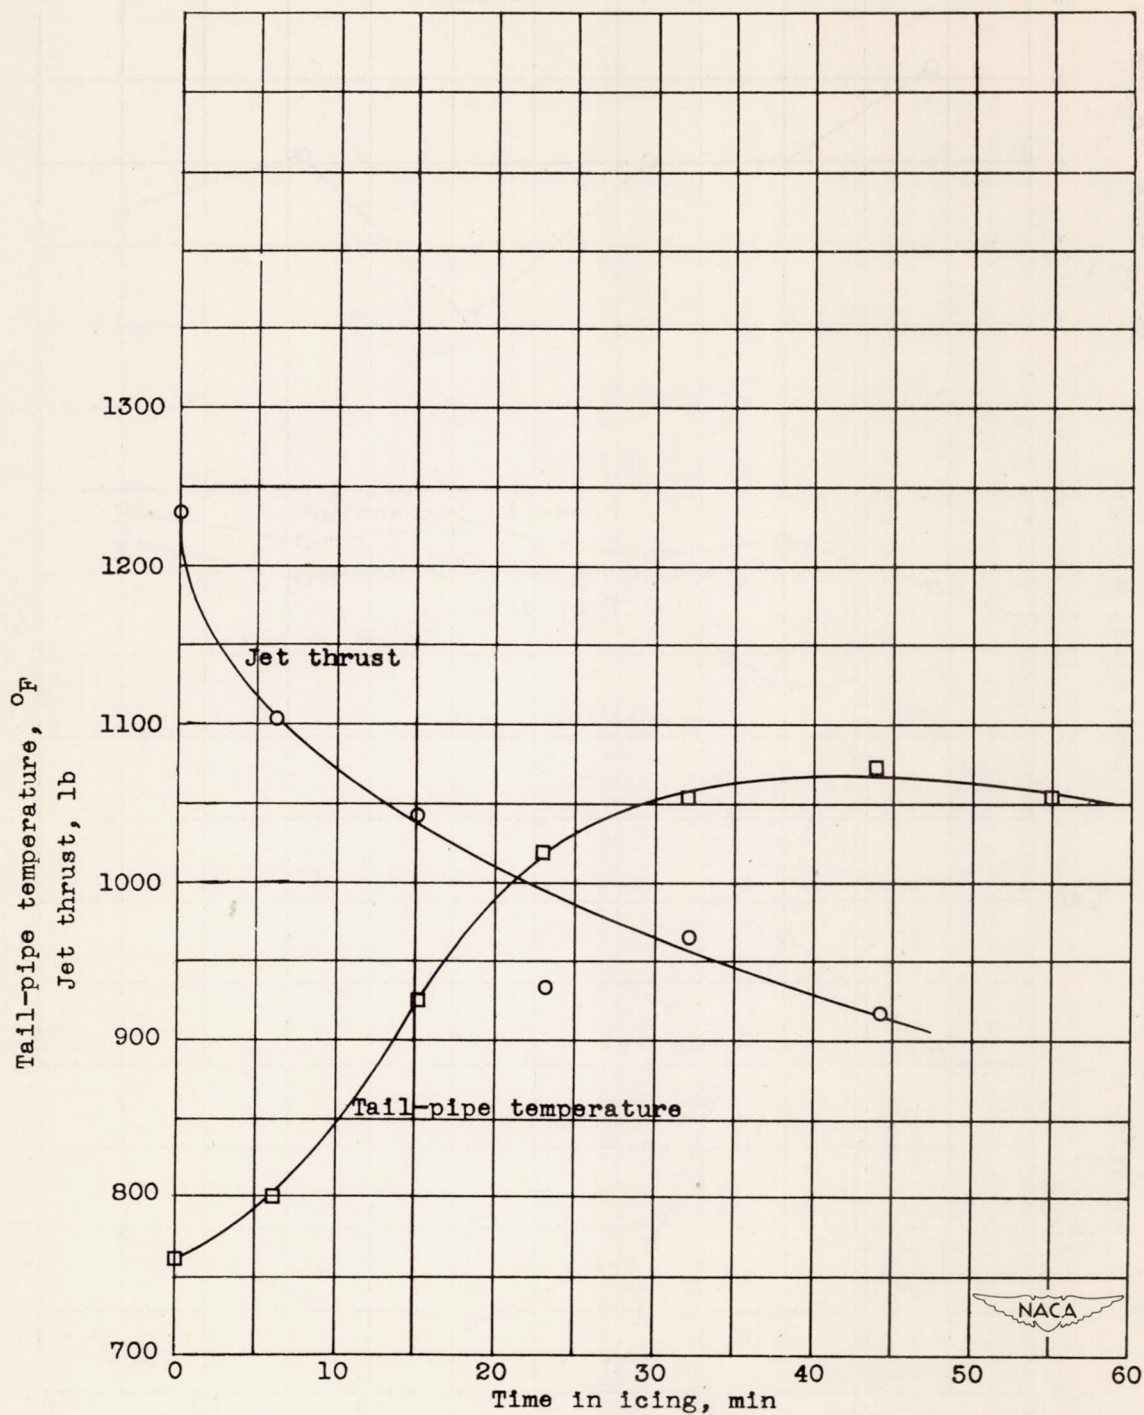
The effect of the ice formation on the engine thrust and tail-pipe temperature is shown in figure 4 as a function of time in the icing condition. The engine was operated at a speed of 9000 rpm in an icing condition for approximately 1 hour. Engine data were taken before the icing cloud was entered and periodically during the encounter with the icing condition. At the end of 45 minutes, the engine thrust had decreased from 1234 to 910 pounds, a reduction of approximately 26 percent. After 45 minutes, the tail-pipe temperature had reached its maximum rise from 761° to 1065° F. At this point during the encounter, the tail-pipe temperature appeared to stabilize. The greatest decrease in thrust and increase in tail-pipe temperature appeared to occur in the first 15 minutes of the encounter.

Figure 4. - Effect of time in icing condition on engine jet thrust and tail-pipe temperature at engine speed of 9000 rpm.

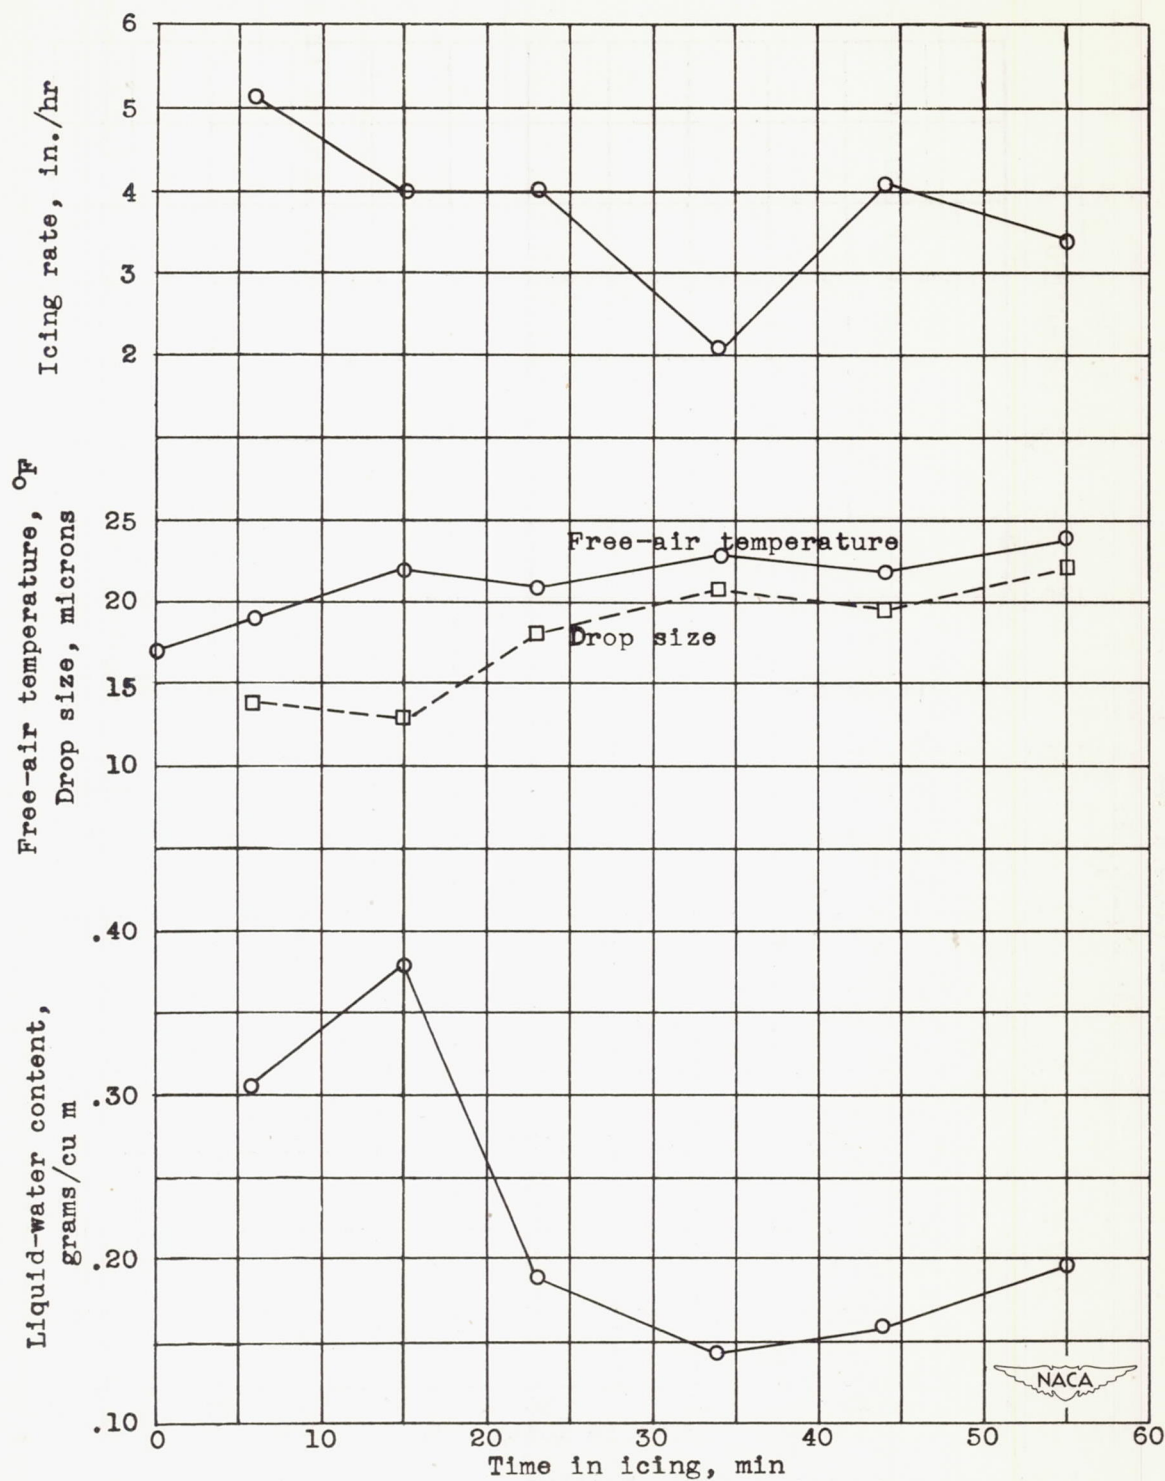
A time history of the icing conditions encountered is given in figure 5, which shows the rate of icing, free-air temperature, drop

size, and liquid-water content. The icing rate varied from 5.1 to 2.1 inches per hour. The free-air temperature and the drop size showed a gradual increase during the encounter. The liquid-water content was highest during the first 15 minutes, reaching a peak value of 0.38 gram per cubic meter and decreasing to approximately 0.17 gram per cubic meter during the remaining 45 minutes.

Figure 5. - Time history of icing condition encountered.
